World Organization Of Building Officials

Tokyo, Japan
April 21, 2004

**“Structural Lessons Learned from the Collapse of the
World Trade Center Towers, New York, USA”**

**By: Imad Eldurubi, WOBO Governor
Deputy Building Official, WILLDAN**

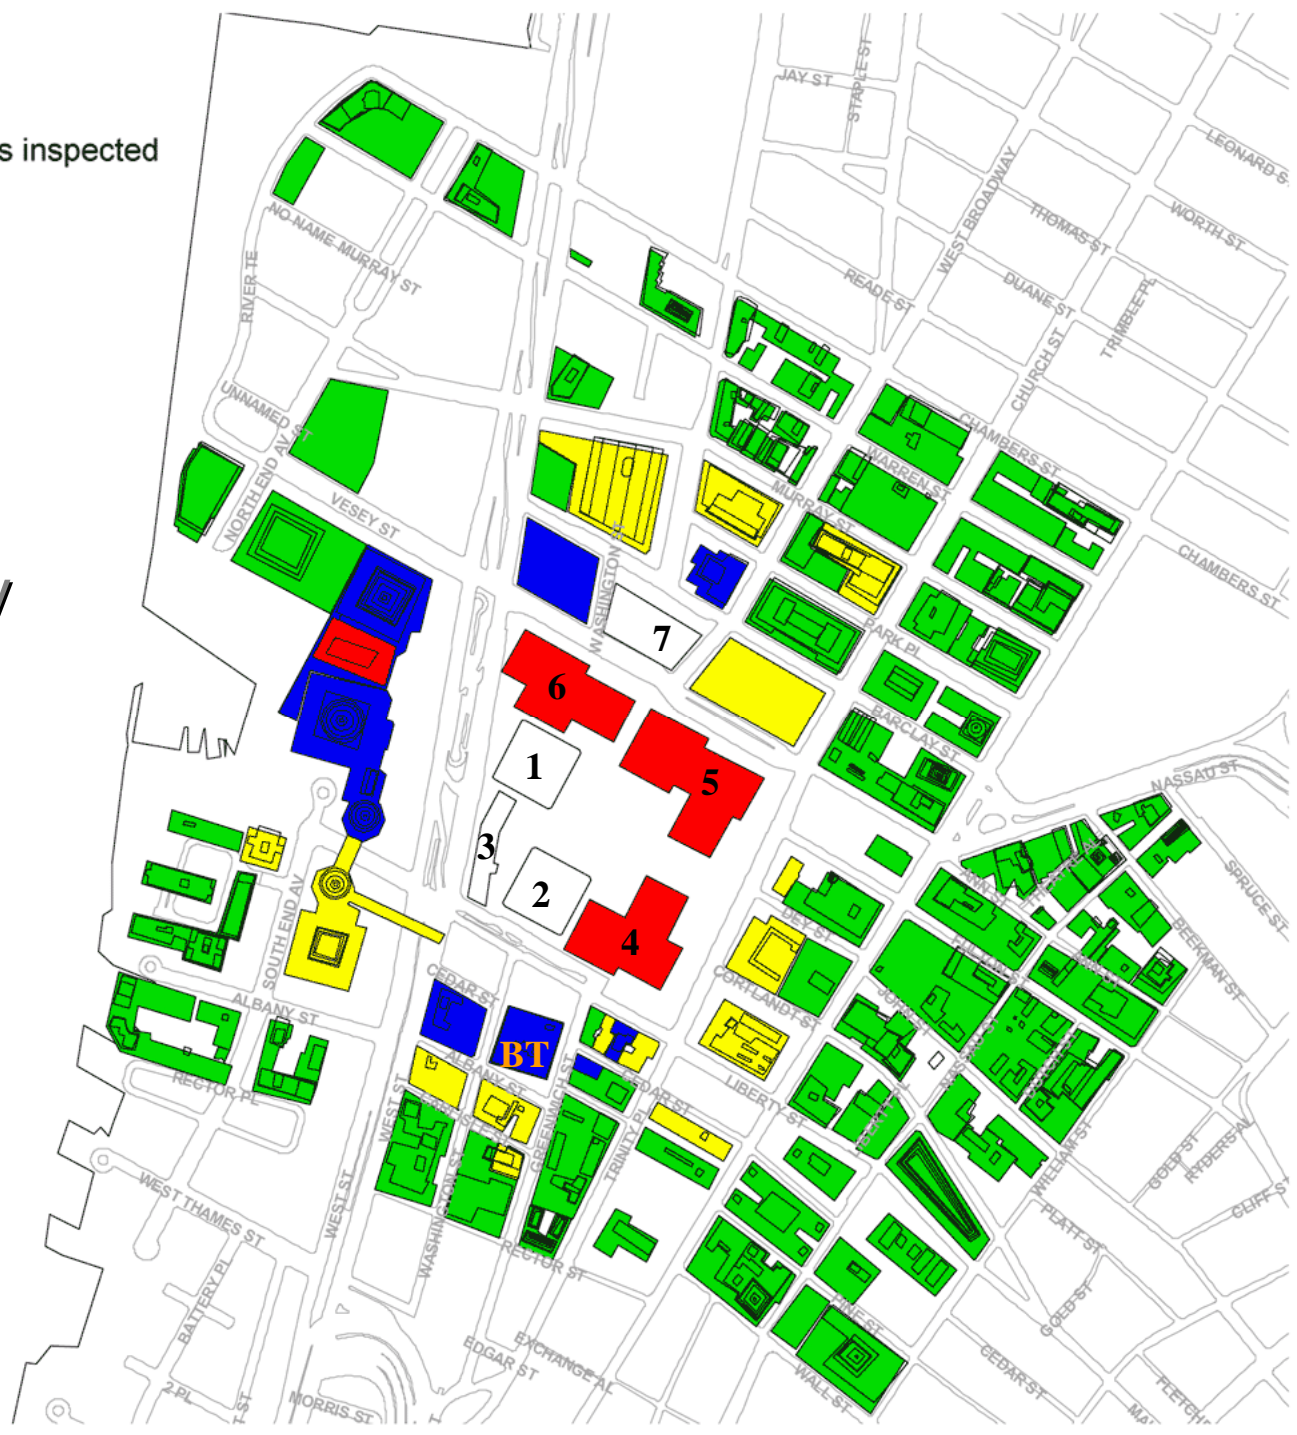
WTC Emergency Building Ratings SEAoNY

- G** No Damage – 384 total buildings inspected
- Y** Moderate Damage – 18 total
- B** Major Damage – 9 total
- R** Partial Collapse – 4 total

NYC DDC/DoB
Cooperative Building
Damage Assessment
22 September 2001

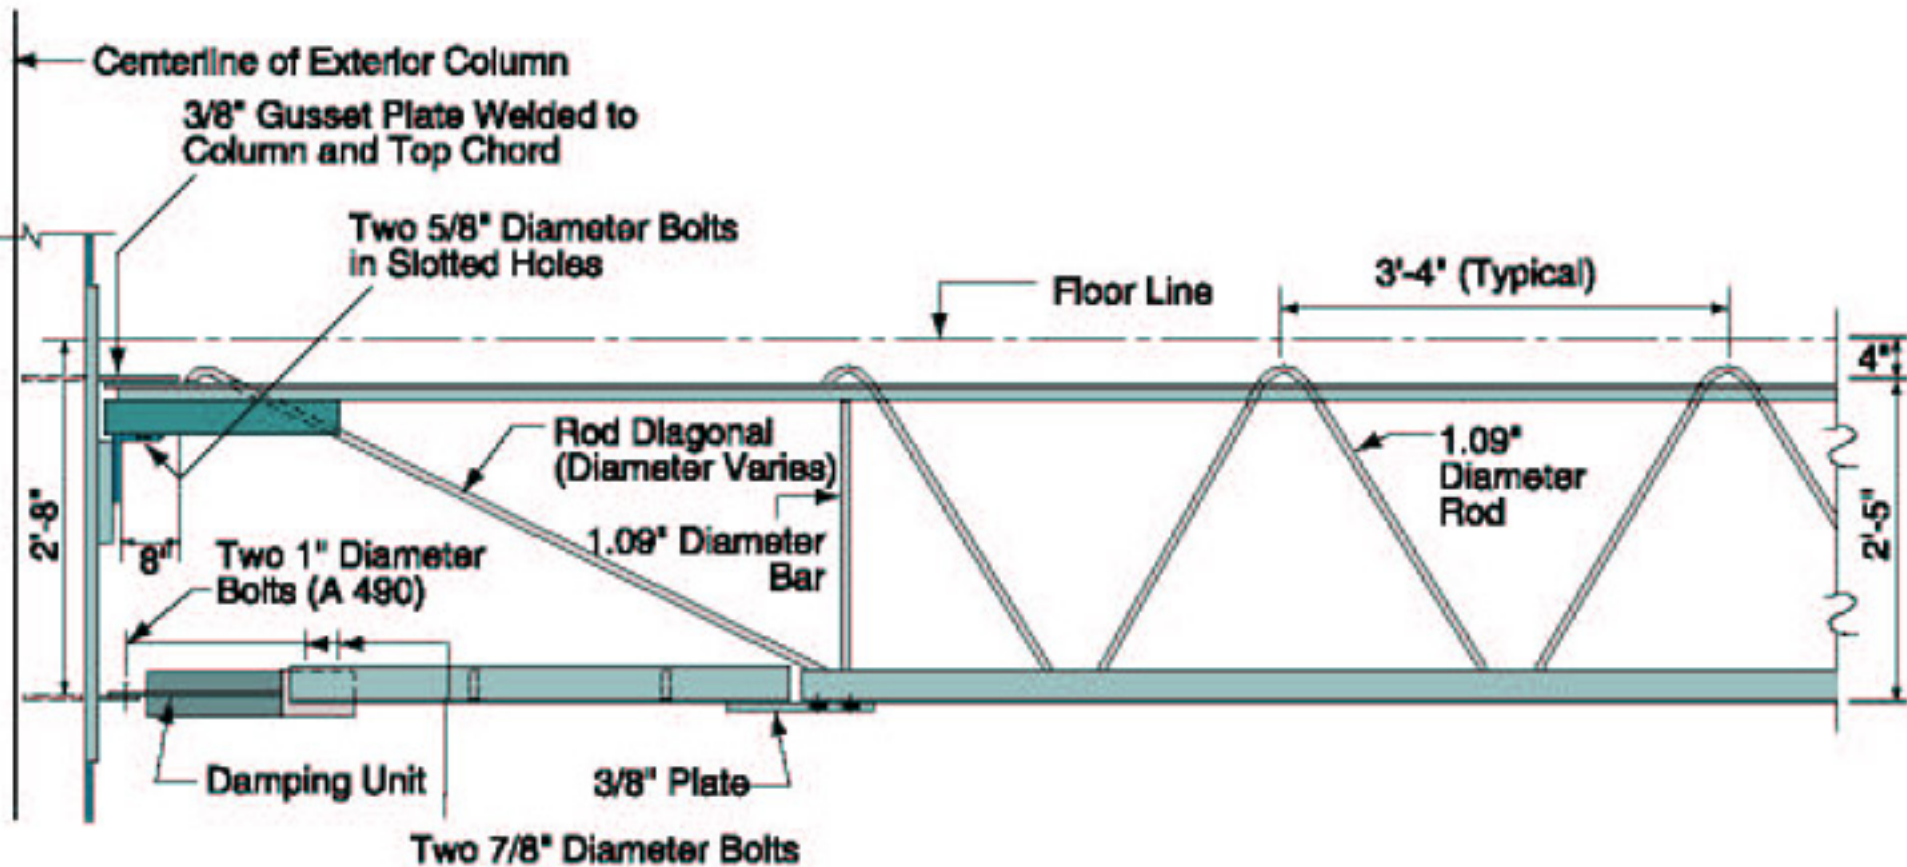
Detail A - Exterior Wall End Detail

Trusses - Exterior Wall End Detail

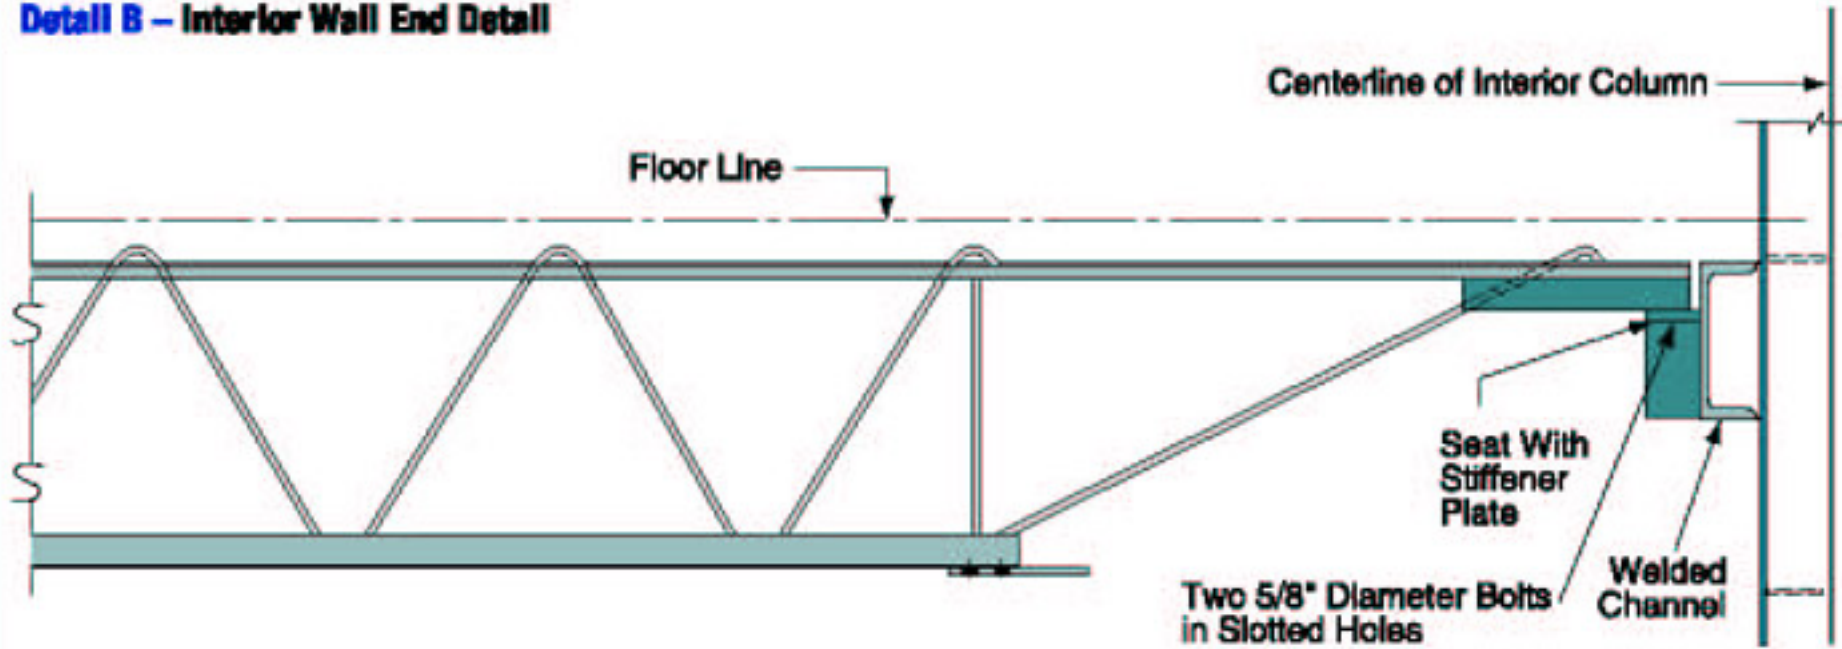
Detail B - Interior Wall End Detail

Trusses - Interior Wall End Detail

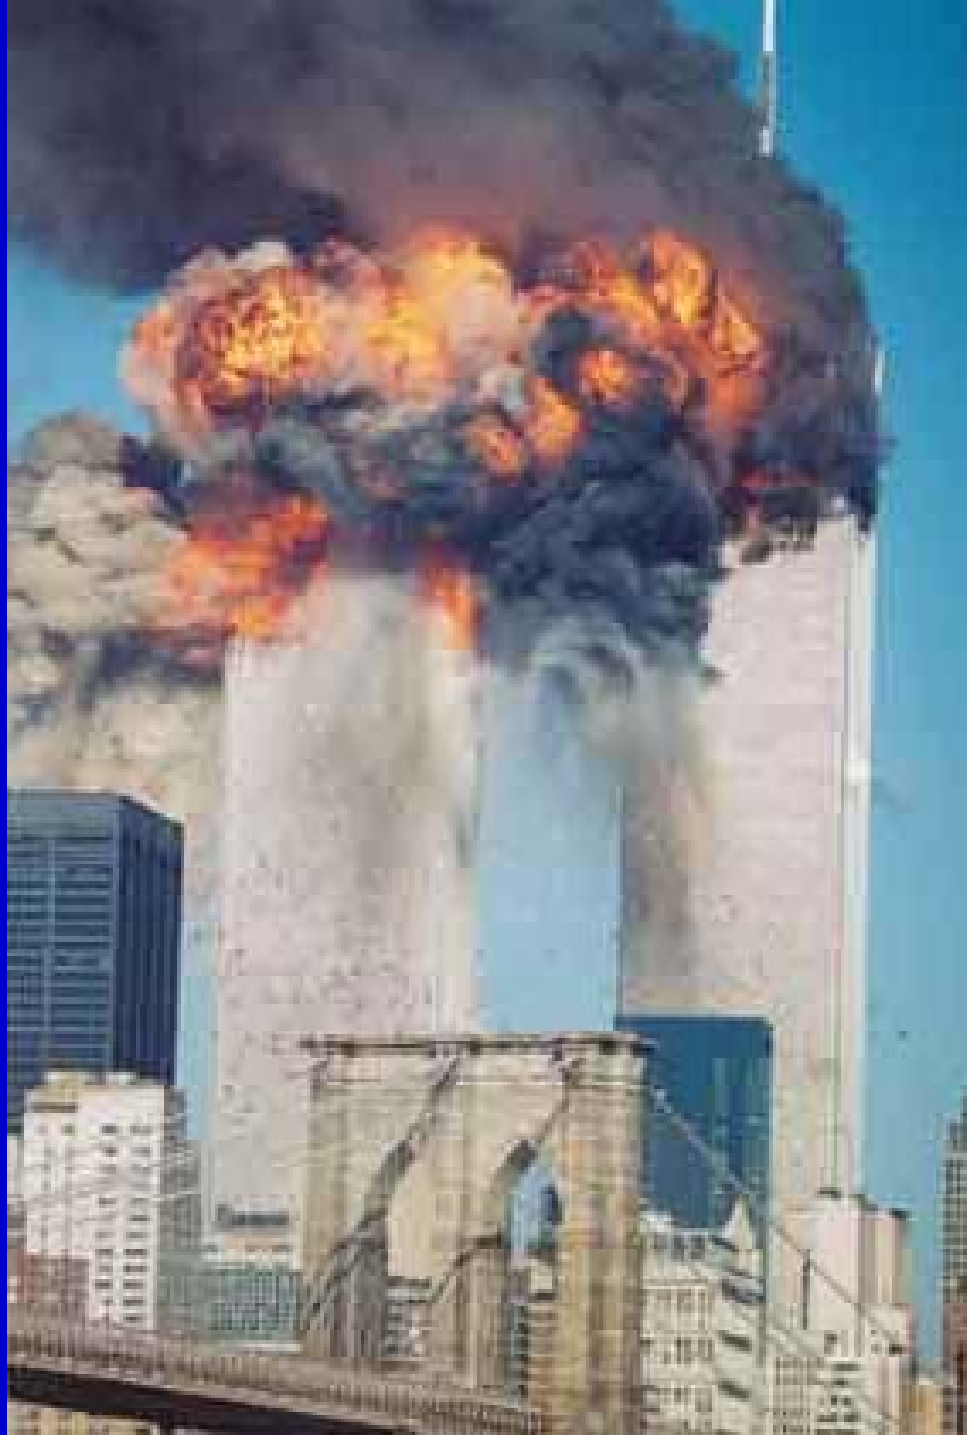
Fireball erupts on north face of the WTC2 as UA175 strikes building

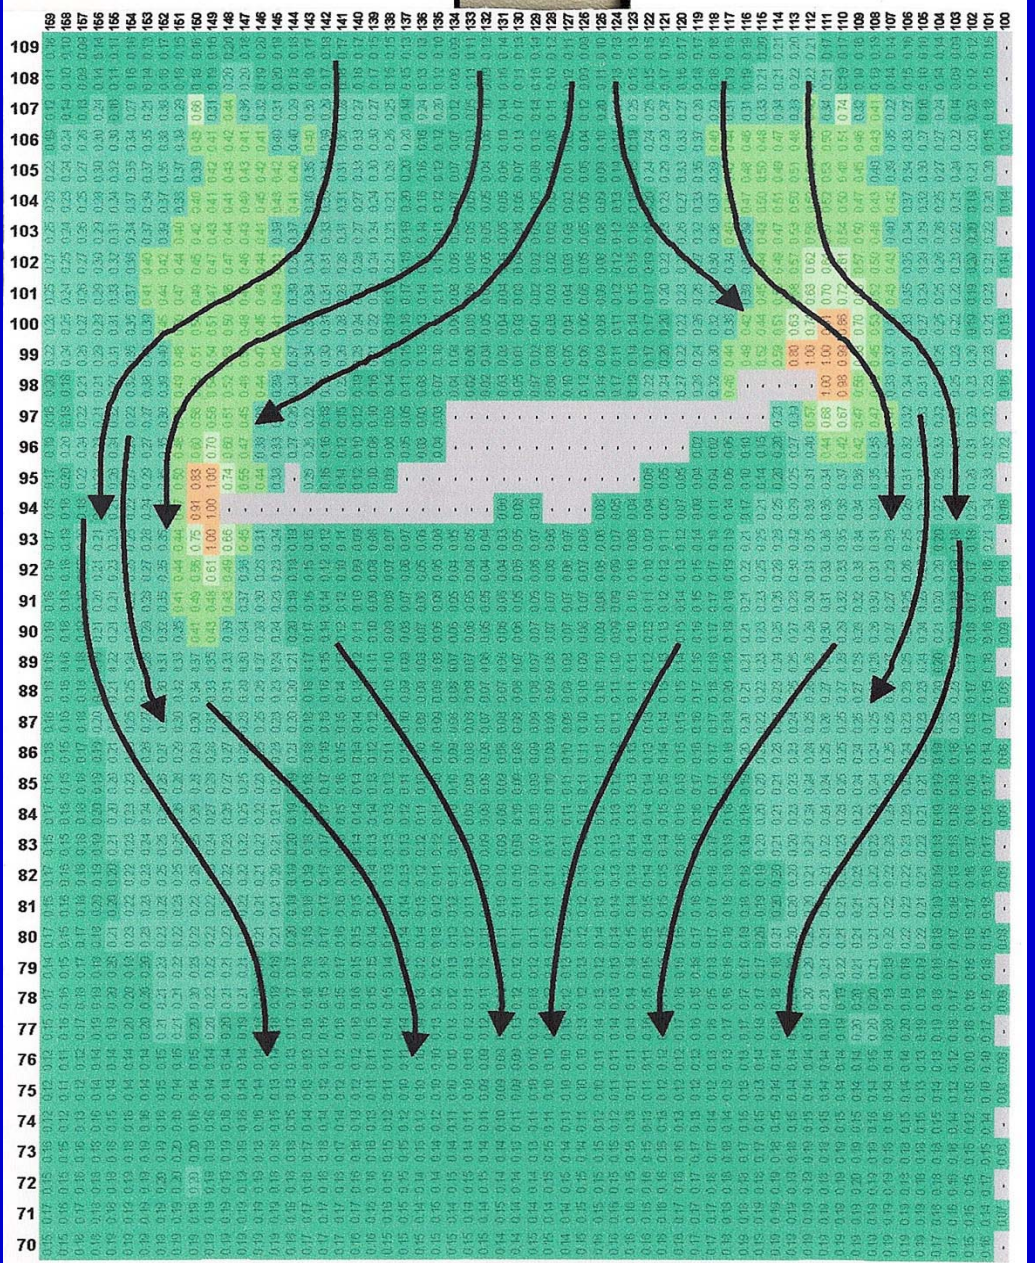
Load Distribution Pattern

COLUMN D/C RATIO RANGES					
< 0.2	0.2 - 0.4	0.4 - 0.6	0.6 - 0.8	0.8 - 1.0	> 1.0

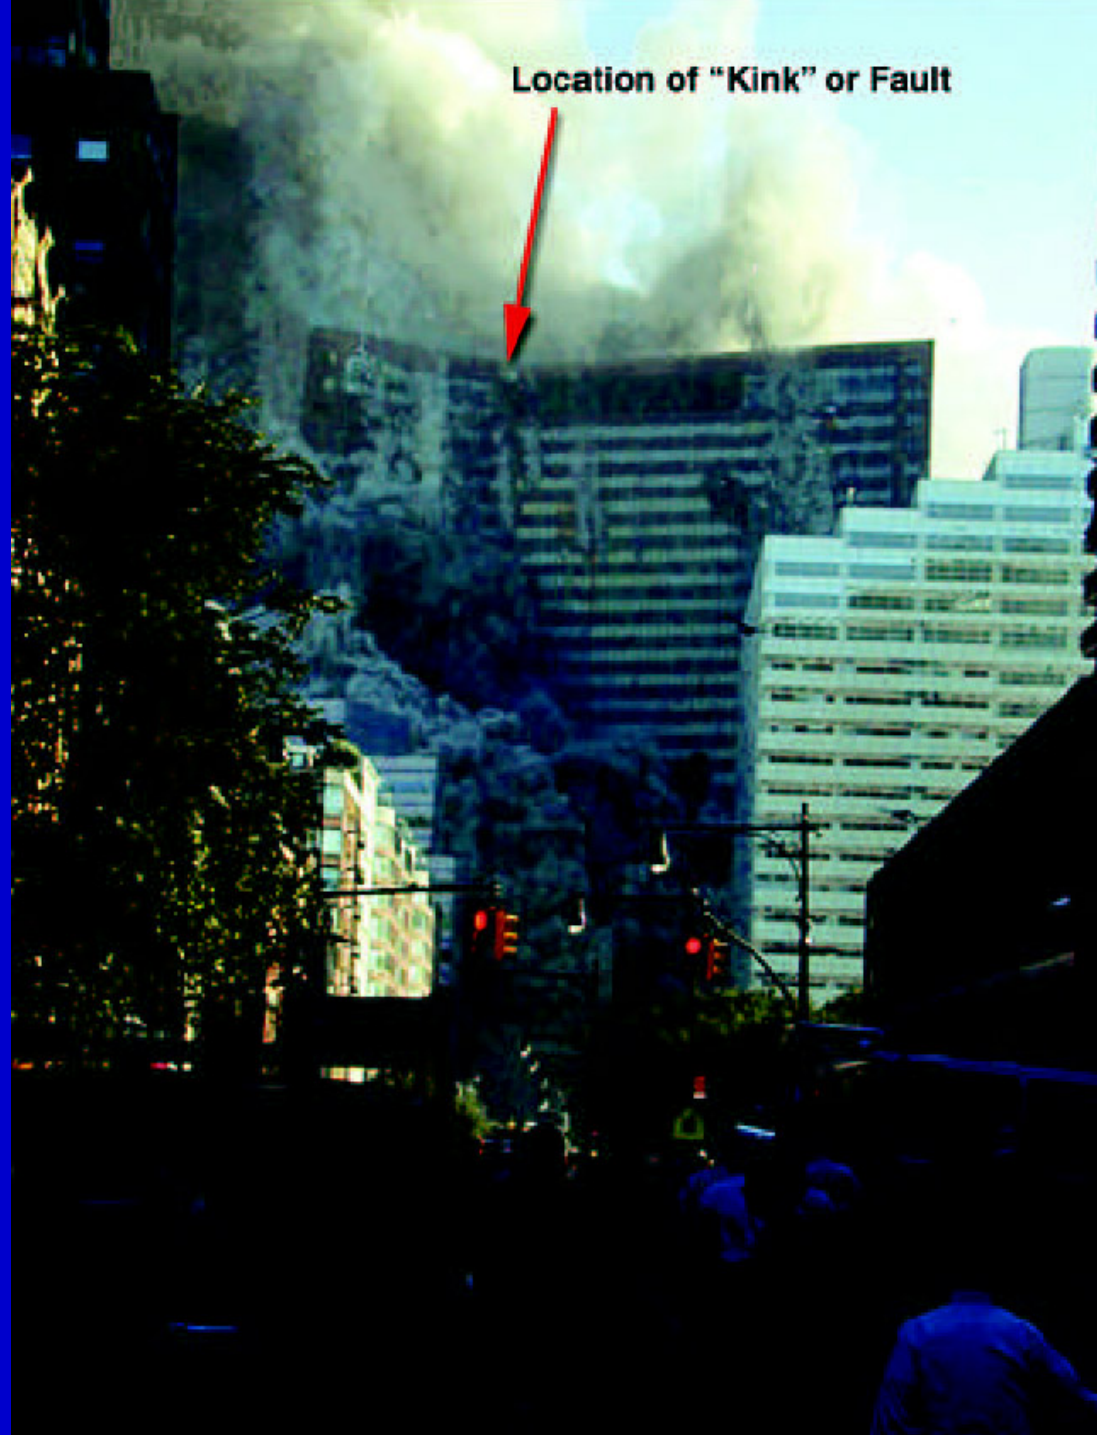
WTC 7 Kink in Building

Location of "Kink" or Fault

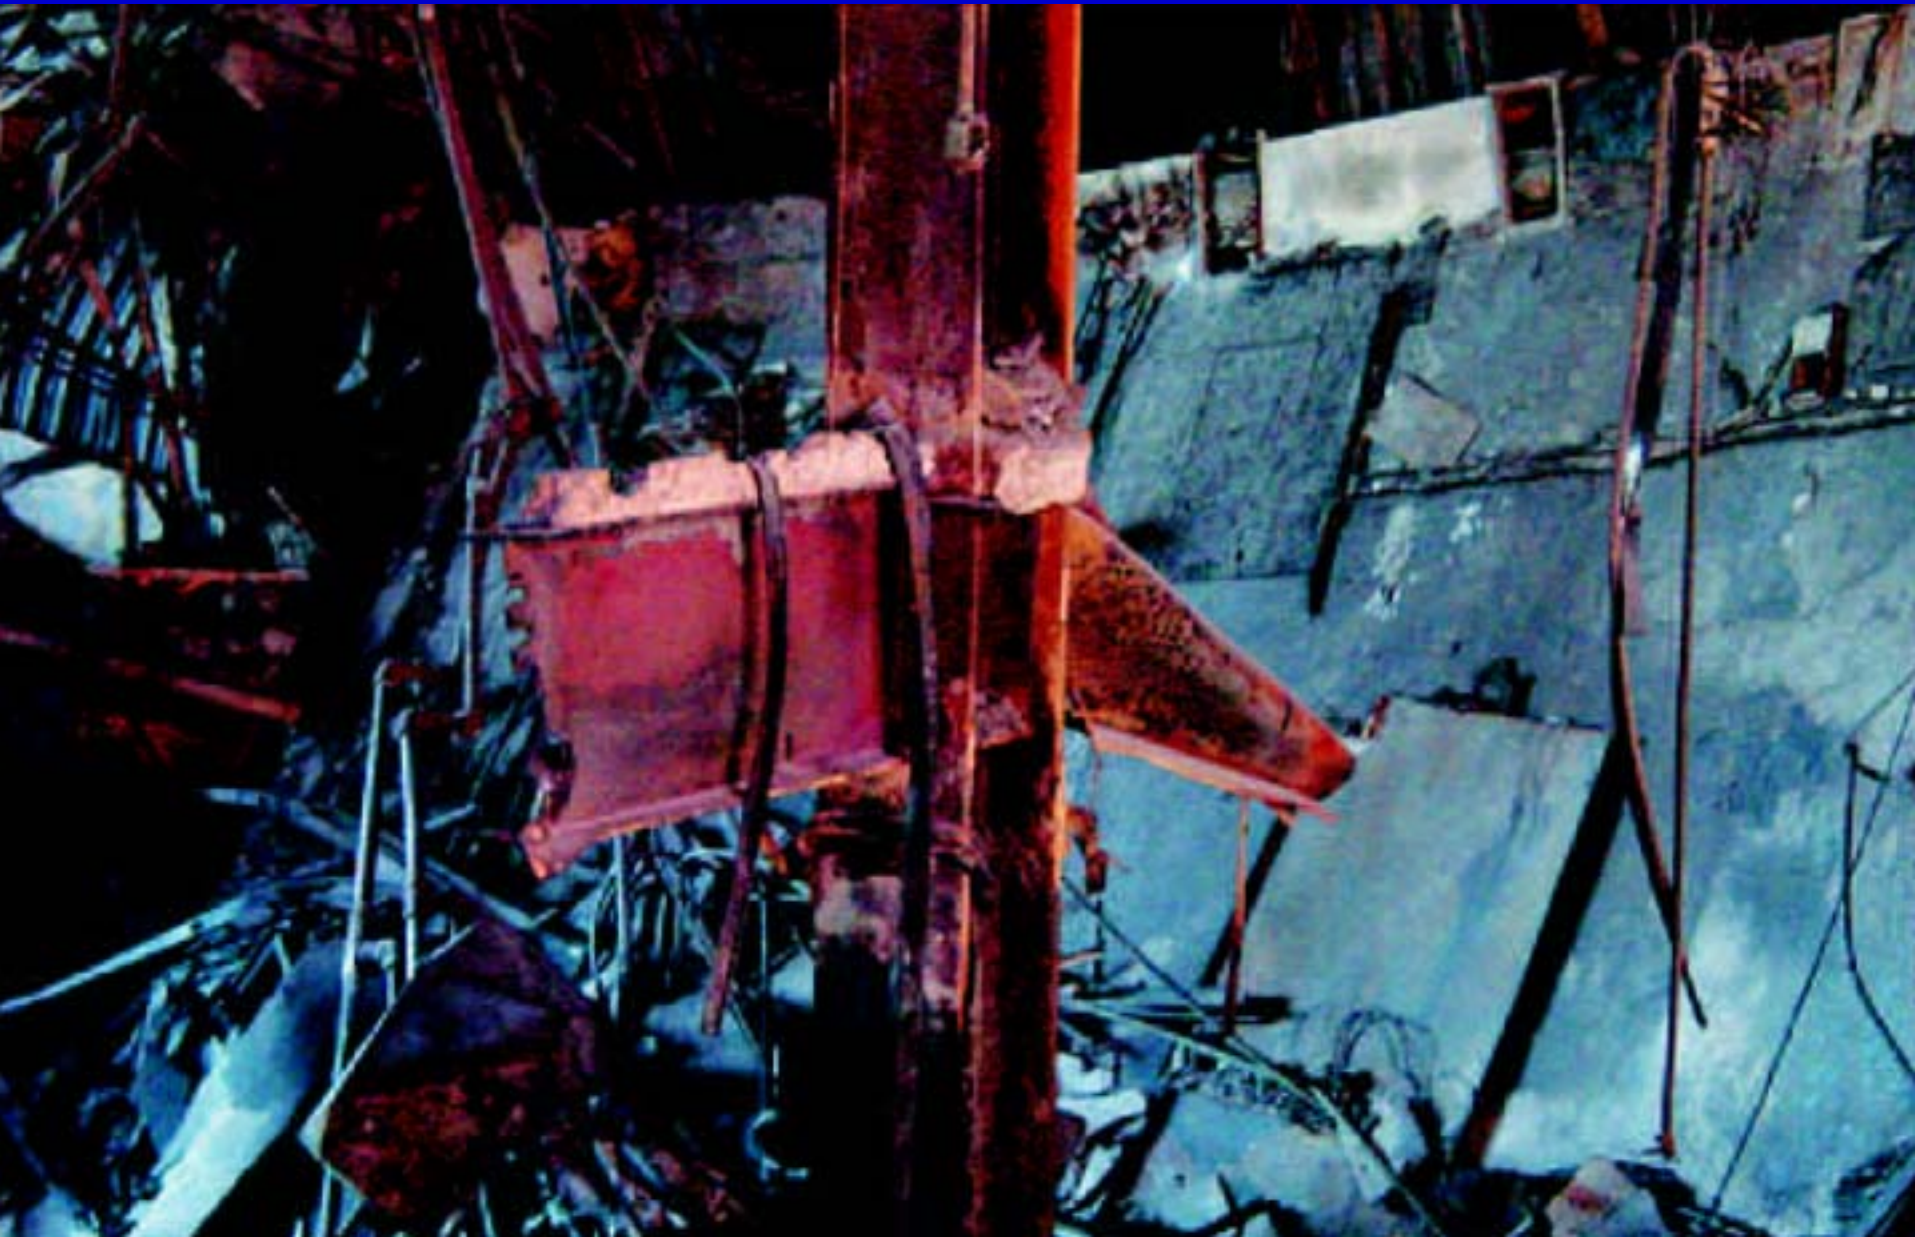
WTC 5 Collapsed Area

W24x61

W18x50

Floor Beam

Shear Tab

Column Tree
